C-12199-0025

## Cozza Commercial Building

South Fayette Township  
Allegheny County, Pennsylvania

WETLAND DELINEATION AND STREAM IDENTIFICATION REPORT

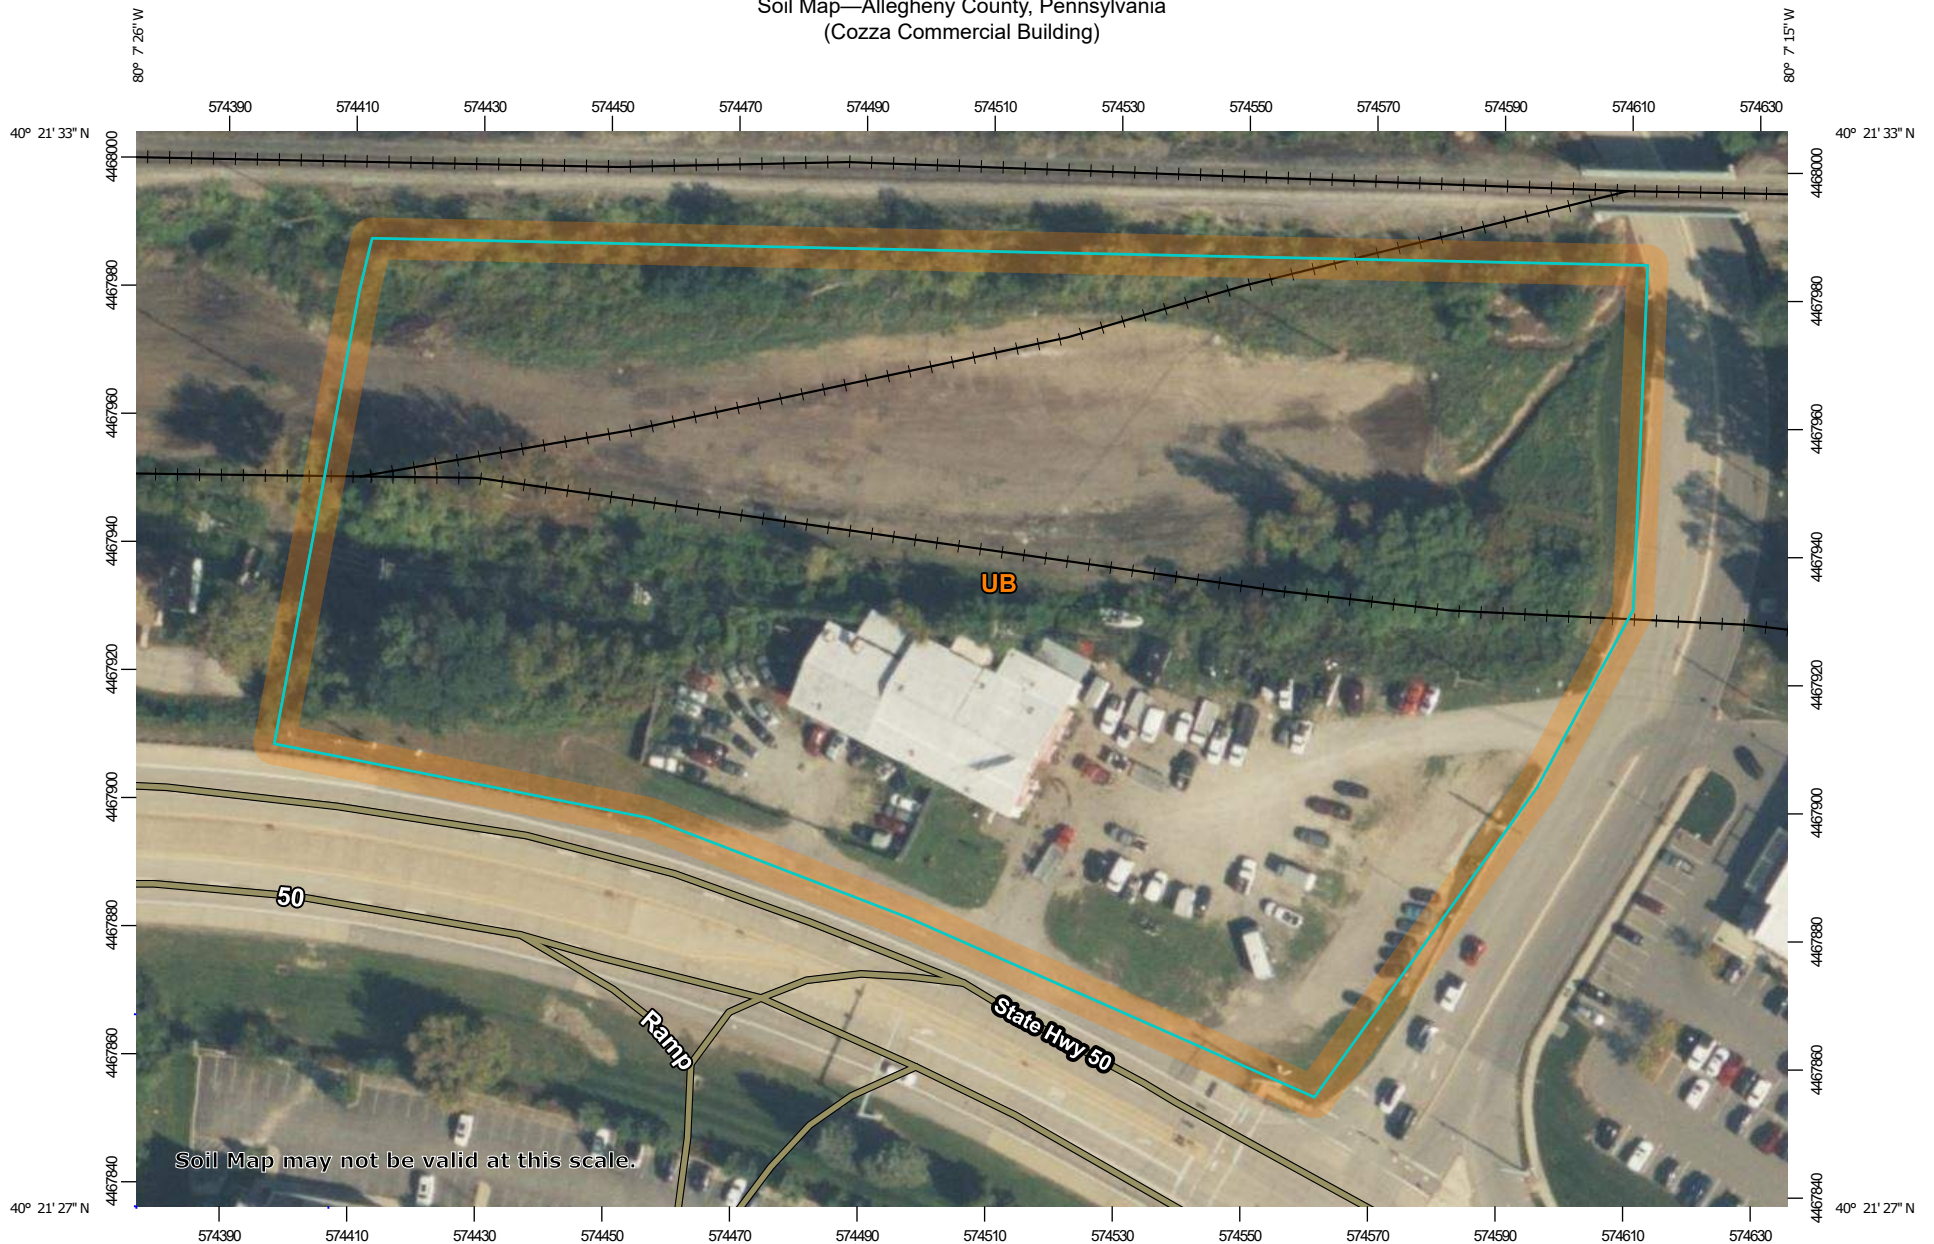
Soil Map—Allegheny County, Pennsylvania  
(Cozza Commercial Building)

Map Scale: 1:1,180 if printed on A landscape (11" x 8.5") sheet.

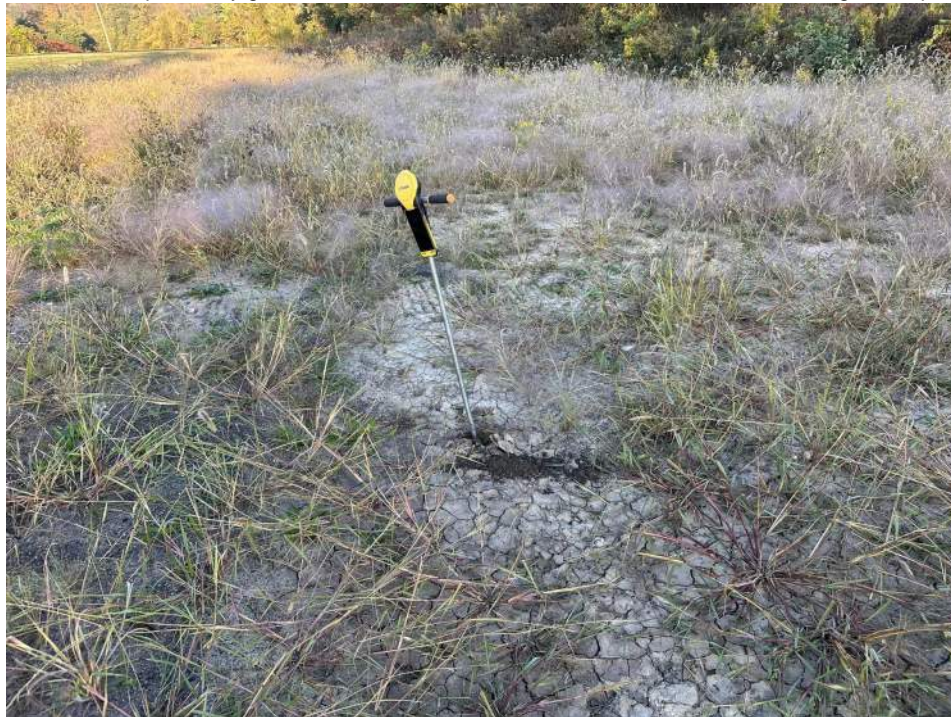
TP-1 Facing West

Remarks:  
 surface soil cracks observed; no other signs of hydrology present. Site is graded to towards a small depression where soil cracks were observed.

Remarks: (Include photo numbers here or on a separate sheet.)  
 Lots of open space between vegetation; the ground is not 100% covered.

Depth (inches)	Matrix		Redox Features				Texture	Remarks
	Color (moist)	%	Color (moist)	%	Type <sup>1</sup>	Loc <sup>2</sup>		
0-9	10YR 2/2	100					Loamy/Clayey	Fill dirt

Area has been previously graded; much of the soil is disturbed and there's not a lot of vegetation present.

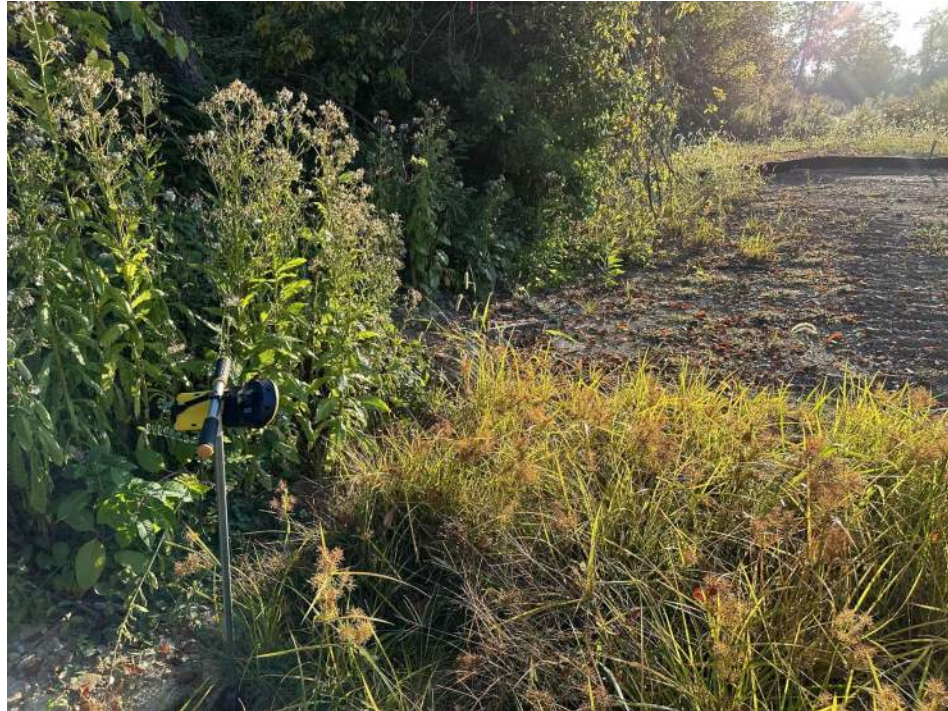
TP-2 Facing East

Remarks:  
 surface soil cracks observed; no other signs of hydrology present. Site is graded to towards a small depression where soil cracks were observed.

Depth (inches)	Matrix		Redox Features				Texture	Remarks
	Color (moist)	%	Color (moist)	%	Type <sup>1</sup>	Loc <sup>2</sup>		
0-6	10YR 4/6	100					Loamy/Clayey	Fill dirt

Area has been filled and graded. The commercial pad drains towards depression at the base of the slope below the railroad.

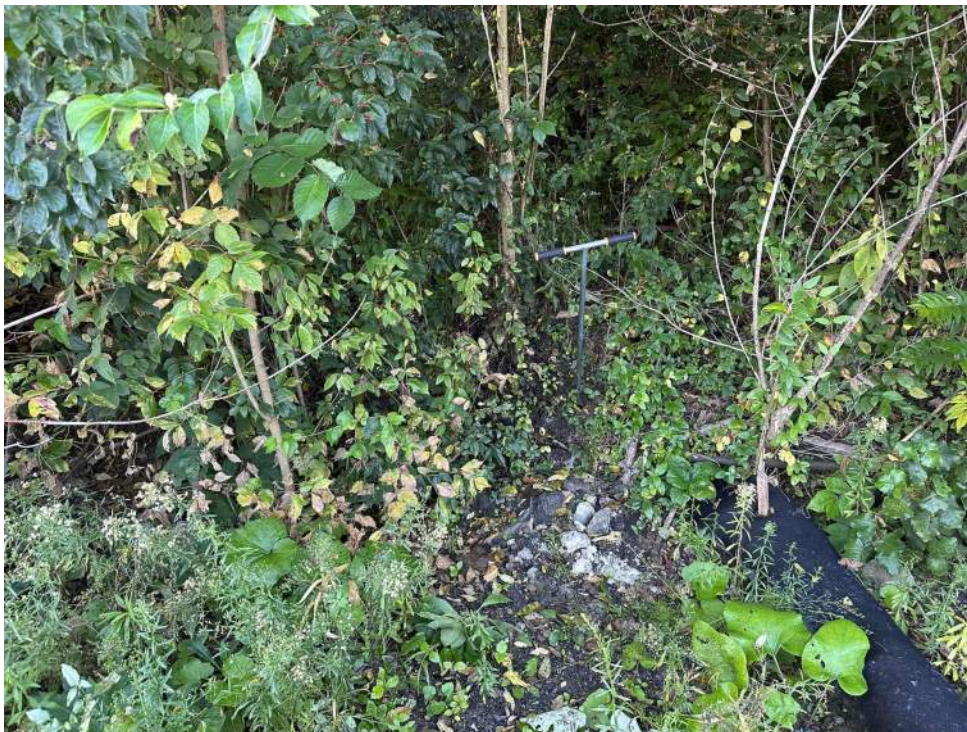
TP-3 Facing South

Hydrophytic Vegetation Present? Yes <u>    </u> No <u>X</u> Hydric Soil Present? Yes <u>    </u> No <u>X</u> Wetland Hydrology Present? Yes <u>    </u> No <u>X</u>	<b>Is the Sampled Area within a Wetland?</b> Yes <u>    </u> No <u>X</u>
Remarks: TP-3

Remarks:  
 surface soil cracks observed; no other signs of hydrology present. Site is graded to towards a small depression where soil cracks were observed.

Depth (inches)	Matrix		Redox Features				Texture	Remarks
	Color (moist)	%	Color (moist)	%	Type <sup>1</sup>	Loc <sup>2</sup>		
0-6	10YR 4/4	100					Loamy/Clayey
